DEPARTMENT OF TRANSPORTATION

Contract #: 04-0120F4Cty: SF/ALA Rte: 80 PM: 13.2/13.9File #: 69.28**WELDING INSPECTION REPORT****Resident Engineer:**Siegenthaler, Peter**Address:** 333 Burma Road**City:** Oakland, CA 94607**Report No:** WIR-018884**Date Inspected:** 17-Nov-2010**Project Name:** SAS Superstructure**OSM Arrival Time:** 700**Prime Contractor:** American Bridge/Fluor Enterprises, a JV**OSM Departure Time:** 1900**Contractor:** Zhenhua Port Machinery Company, Ltd (ZPMC), Changxing Island **Location:** Shanghai, China**CWI Name:** Gang Wei**CWI Present:** Yes No**Inspected CWI report:** Yes No N/A**Rod Oven in Use:** Yes No N/A**Electrode to specification:** Yes No N/A**Weld Procedures Followed:** Yes No N/A**Qualified Welders:** Yes No N/A**Verified Joint Fit-up:** Yes No N/A**Approved Drawings:** Yes No N/A**Approved WPS:** Yes No N/A**Delayed / Cancelled:** Yes No N/A**Bridge No:** 34-0006**Component:** OBG**Summary of Items Observed:**

WELDING INSPECTION REPORT

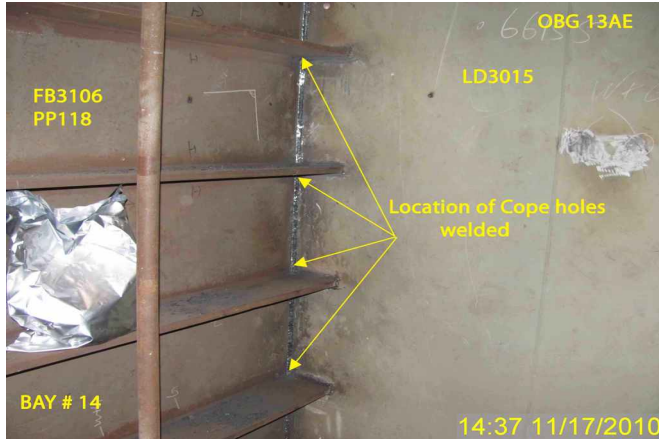
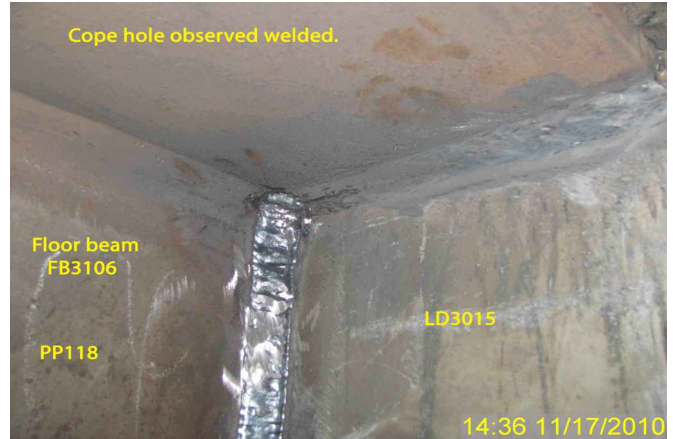
During the random visual inspection of OBG segment 13AE this QA Inspector observed cope holes at the weld joints between floor beam (FB3106) stiffeners to the longitudinal diaphragm (LD3015) was welded. This QA Inspector informed to ZPMC QC and ABF QA Inspector. For more detail see attached photos.
